Mator News

How to ensure a successful separator modification?

Offshore testing examples

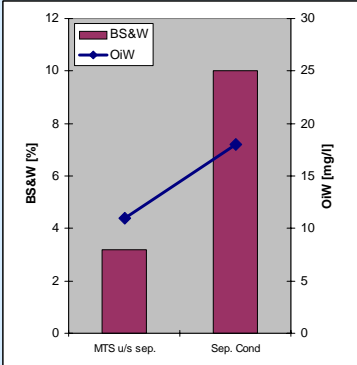
Possible problem cause	Method	Results	Conclusion
Suspicion of emulsifying conditions within the separator	MTS – separation testing

Results indicate that the separator itself is causing negative effects on both water and oil phases. Further work to address this.
Suspicion of skewed distribution at separator inlet	Neutron Backscattering

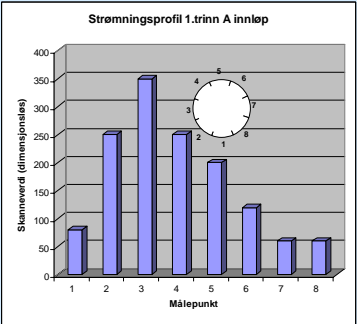
Results show clearly skewed distribution. Risk of gas carry-under with possible increased foaming and/or emulsification.
Suspicion of short circuiting or clogged internals in the separator	RTD analysis using tracers

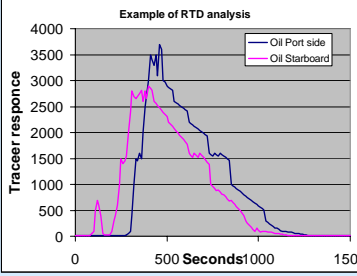
Different oil retention time in separator and evident short circuit current on one side.
